**UNIVERSITY OF GUAM CULTURAL REPOSITORY FACILITY  
LOT 5372-3A, MAGA, MUNICIPALITY OF MANGILAO  
ISLAND OF GUAM**

**FINAL ENVIRONMENTAL ASSESSMENT**

**JULY 13, 2020**

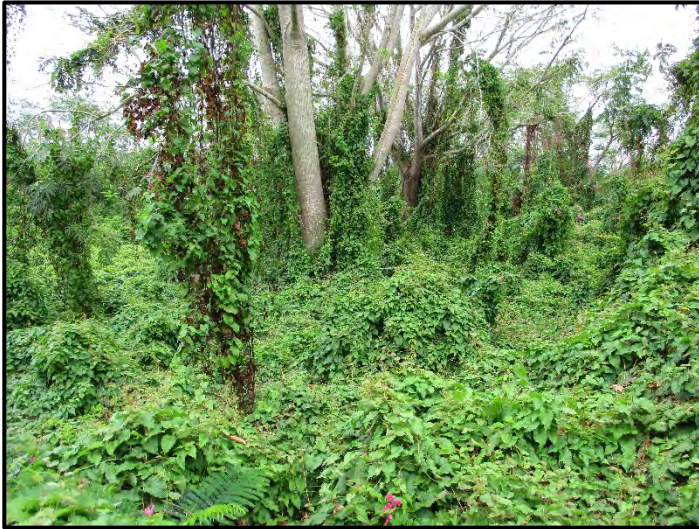
Photograph 10. The entire subject property was densely vegetated with trees, brush, and vines (15 March 2019).

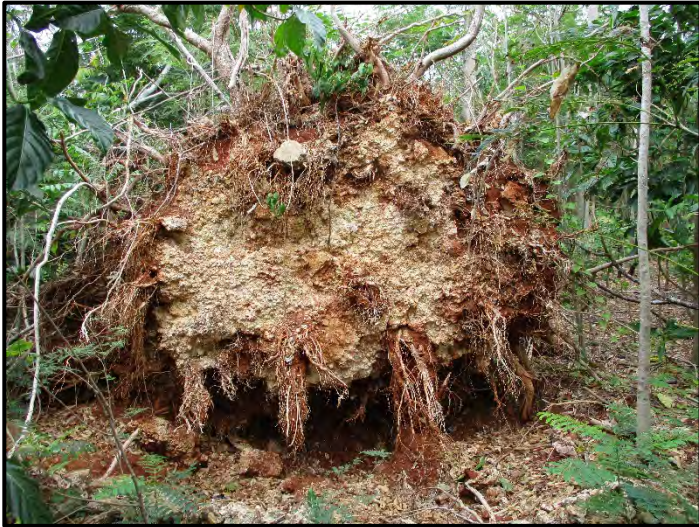
Photograph 11. Two large uprooted trees were observed in the center of the subject property (15 March 2019).

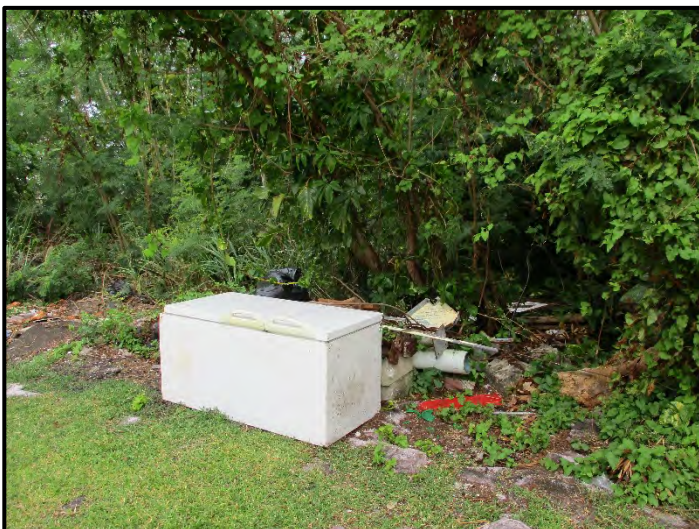
Photograph 12. A discarded refrigerator and trash were observed on the southwestern boundary of the subject property, near an apartment building on Atbut Lane (15 March 2019).

Three *recognized environmental conditions* were identified in connection with the project site. An illegal dump area was found on the southwestern portion of Alternative A and the southeastern portion of Alternative B. Two abandoned vehicles, appliances, and municipal solid waste were observed in this area. The abandoned vehicles likely contain residual petroleum products. One pole-mounted transformer was observed to the south of Alternative A and showed visible staining. A second stained pole-mounted transformer was observed approximately 500 feet north of Alternative A. It is unknown if the transformers contain polychlorinated biphenyls (PCB).

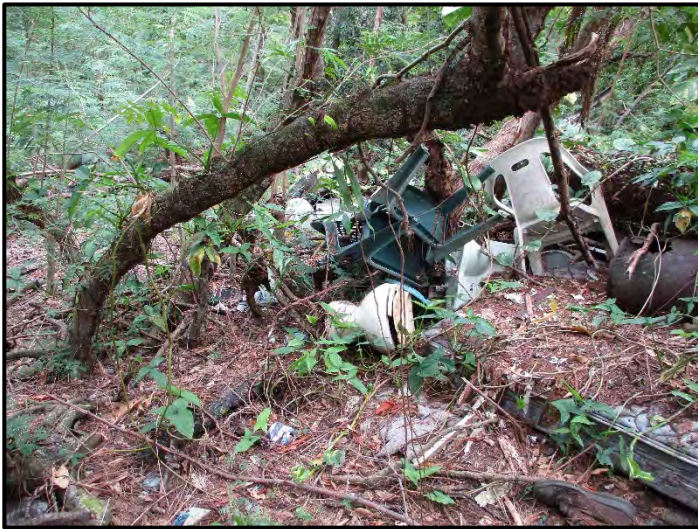
Photograph 13. Additional municipal trash observed on the southwestern boundary of the subject property, near an apartment building on Atbut Lane. No hazardous substances or petroleum products were observed in the dump area (15 March 2019).

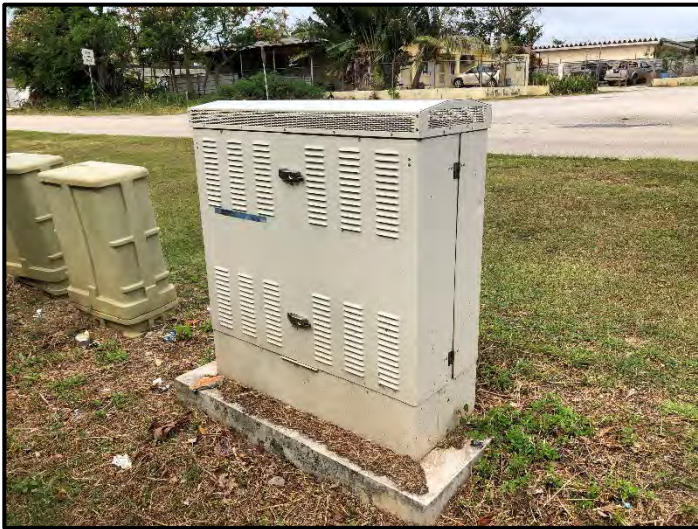
Photograph 14. Three telephone junction boxes were observed on the eastern portion of the subject property, along University Avenue (09 May 2019).

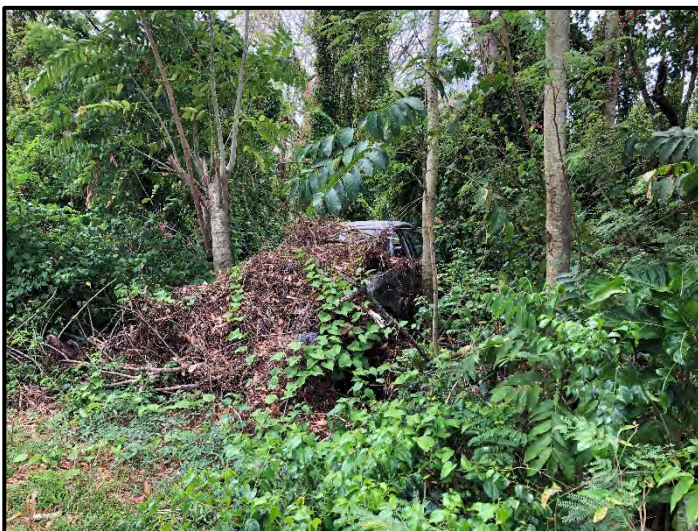
Photograph 15. One of two abandoned vehicles observed on the southwestern boundary of the subject property. The vehicle was observed in poor condition and was overgrown with vines (15 March 2019).

Two abandoned vehicles were observed in the southwestern portion of the subject property. One of the vehicles was observed in poor condition and was overgrown with vines (Photograph 15). The ground surface around and beneath the vehicle could not be inspected due to the vegetative ground cover. The other vehicle was observed in moderate condition, with no fluid leaks or staining visible around or under the vehicle (Photograph 16).

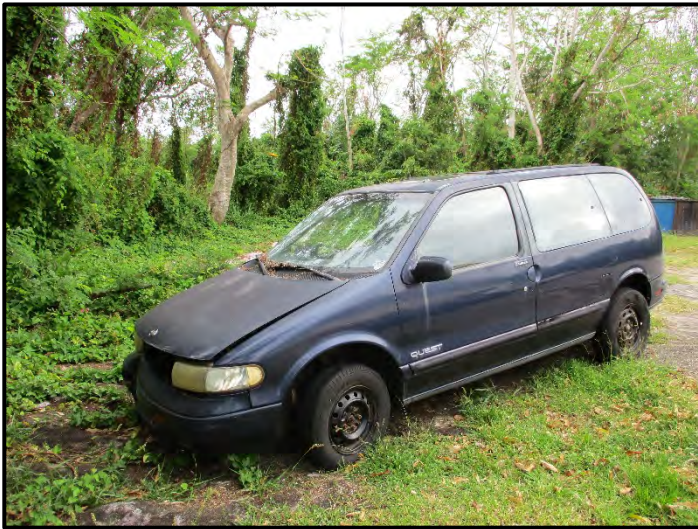
Photograph 16. The second abandoned vehicle observed on the southwestern boundary of the subject property. The vehicle was observed in moderate condition (15 March 2019).

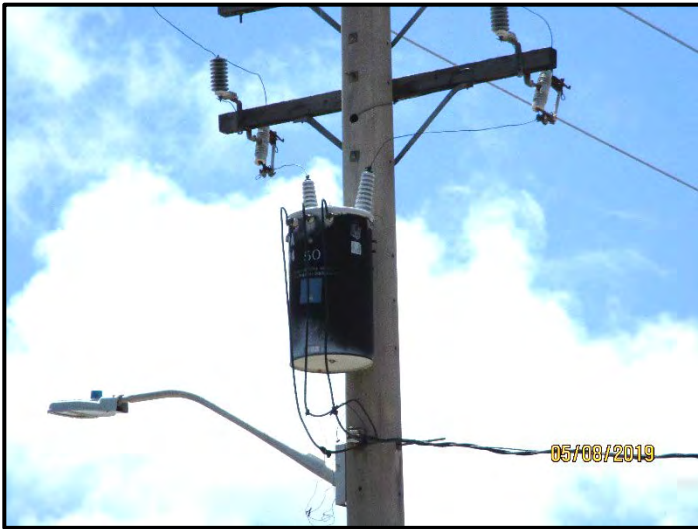
Photograph 17. One pole-mounted transformer was observed to the northeast of the subject property, along University Avenue. Black staining was visible on the exterior of the transformer (09 May 2019).

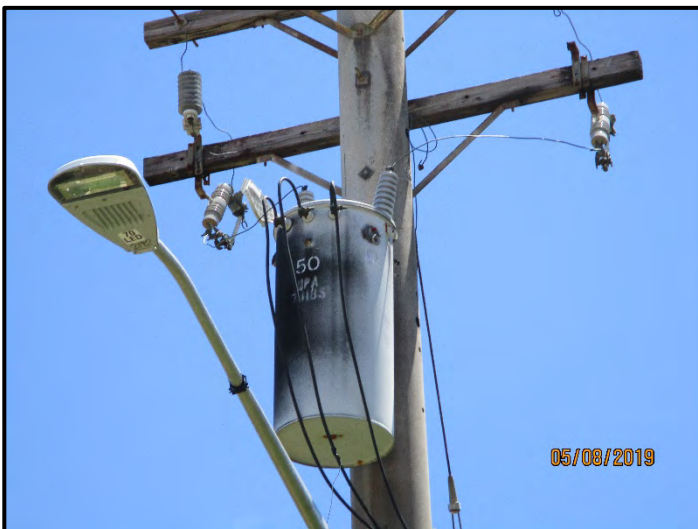
Photograph 18. One pole-mounted transformer was observed to the south of the subject property, along Atbut Lane and at an apartment building. Black staining was visible on the exterior of the transformer (09 May 2019).
